# U.S. 101 MP 102.97 Unnamed Tributary to Big Creek (WDFW ID 990033): Preliminary Hydraulic Design Report

Paul DeVries Ph.D., PE, CFP, FPT20-11347
Stream Design Engineer, Fisheries Biologist, Fluvial Geomorphologist
Kleinschmidt Associates

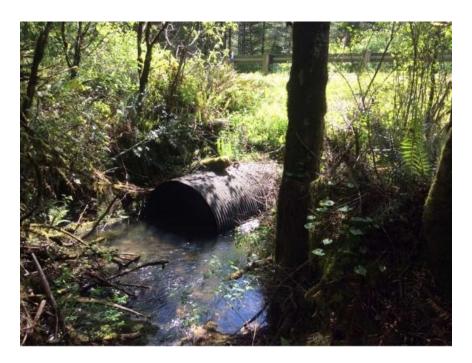
Figure 6: Culvert inlet

The existing structure is a 96-feet-long, approximately 43-inch-tall by 73-inch-wide corrugated metal pipe arch culvert with a gradient of approximately 0.1 percent. It is inferred from the surrounding topography that the original channel was straightened when the culvert was installed by shortcutting a relic channel meander (see Section 2.8.2). The inlet is situated below a hardpan grade control that forms a steep step below a much lower gradient segment of channel upstream (Figure 6). The outlet of the culvert is directed at a roughly 3 to 4 feet high vertical right bank (Figure 7), which curves sharply to the left within approximately 10 feet of the downstream end, indicating that high flow velocities exiting the culvert are insufficient to erode the underlying hardpan. This suggested low energy during flooding is consistent with observations of fine sediment accumulations above hardpan grade controls (see next section). There was some racking of debris at the downstream end of the culvert outlet scour pool.
